Compatibility Considerations for UST Systems

Final Report

October 2015

**Emerging Fuels Task Force
Tanks Subcommittee**

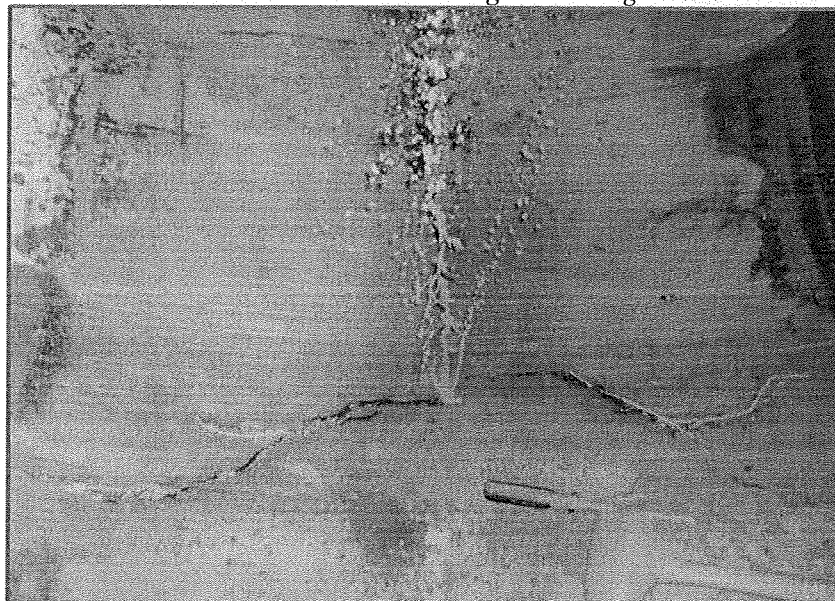
92 Octane UST interior – water entering tank through crack

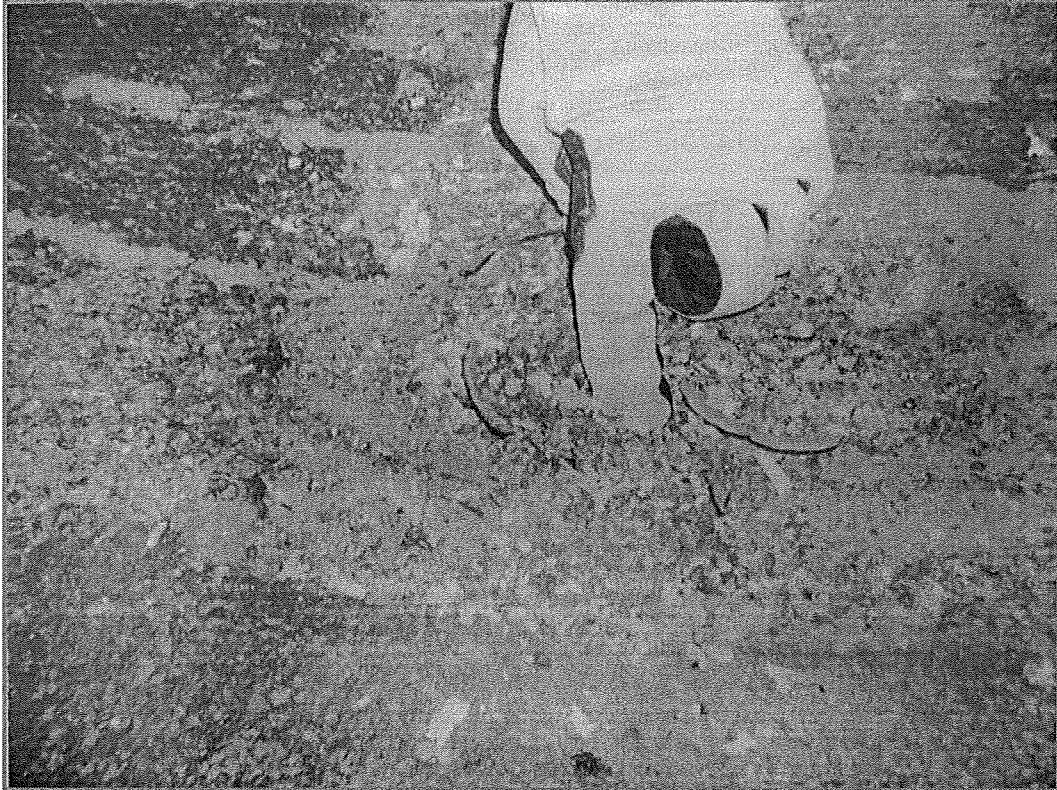
UST 87 Octane internal view: gel deterioration

All three USTs showed severe deterioration of internal Gel coat with exposure of fiberglass fibers. There were visible cracks as well as a 2.5 feet long crack on the bottom center and at both ends of the premium UST. There was one (1) large area of crazing in the plus tank. All tanks were eventually lined and returned to service on 10/21/2009.

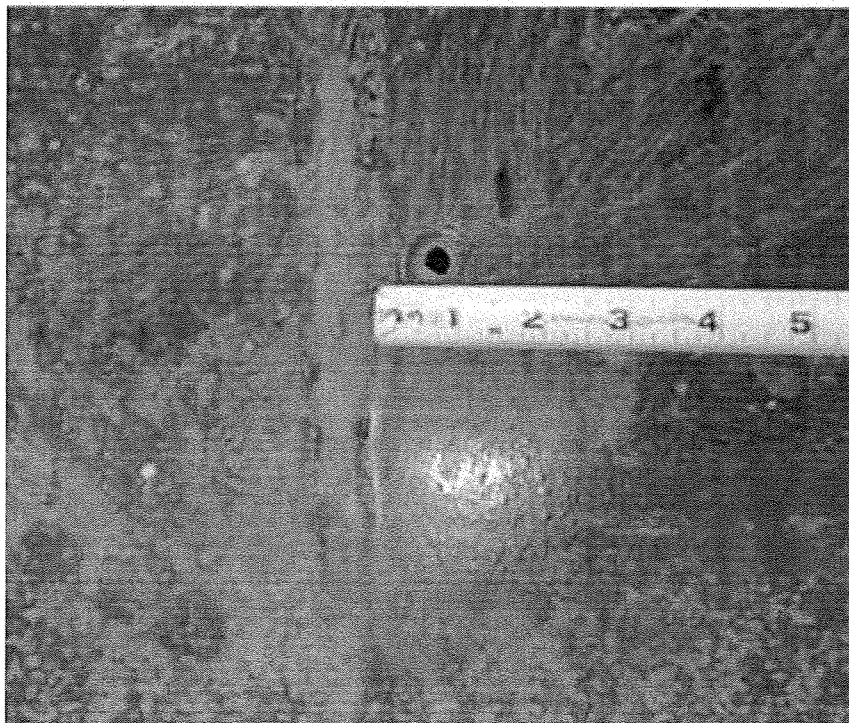
Explosive vapors in building adjacent to site (required evacuation of building). Release was confirmed, LNAPL identified in monitoring well (depth to water: 10-13 feet), estimated volume of loss 9,700 gallons, actual gasoline recovered >14,000 gallons.

Supporting Pictures:*Exterior Photo*

Release from perforation in tank caused by internal corrosion. Tank was removed. Total cleanup costs estimated at over \$900,000. Tank owner is in litigation with tank manufacturer.
