# Status of the Watershed 2016

The Upper White River in Arkansas and Missouri

Summarizing 2015 Water Quality in the Upper White River Basin

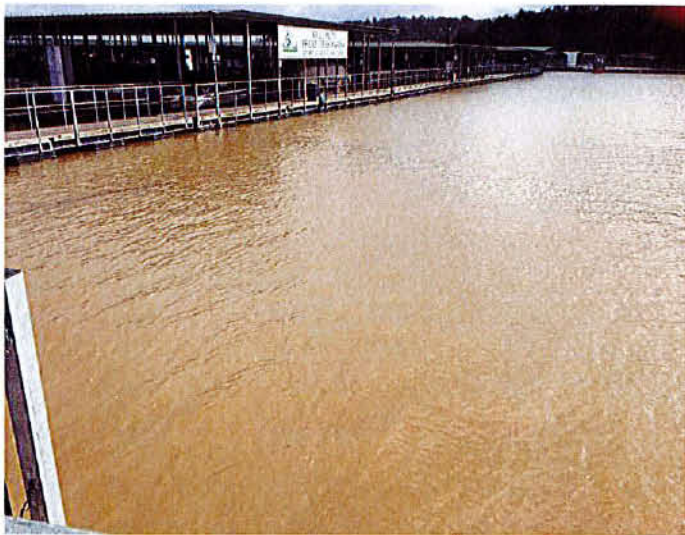
**Above: Beaver Lake at Prairie Creek after historic rainfall in late December, 2015**

Occurrence of this excessive rainfall during the leaf-off season caused tremendous amounts of sediment (soils and debris) to wash into the streams, rivers and lakes. Extreme sediment loading was visible in the brown and rusty color of the rivers and lakes which lasted well into early spring of 2016. As water receded, this mud layer became exposed to wind and wave action which re-suspended the sediment in the water. Many residents and visitors to the lakes had never seen the volume and extent of sediment deposition which

occurred with this event. This murkiness was also widespread throughout the entire length of the lakes, rather than primarily where rivers enter the lakes which is normally the case. As the lakes began to turn over (a natural occurrence as seasonal temperatures change) the cloudiness of the water was extended and the settling of sediment was interrupted by the mixing of water layers in the lakes.

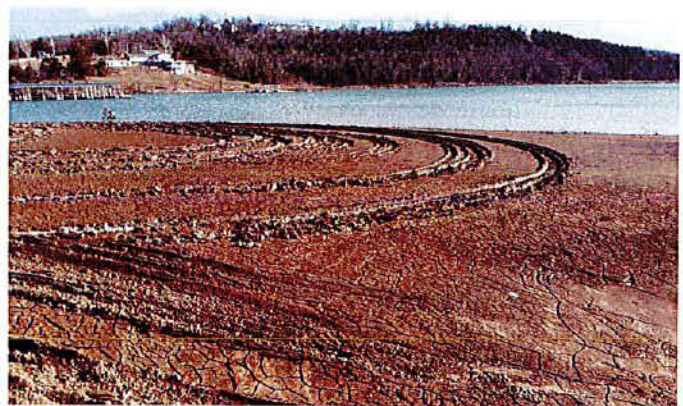
**Above: Cape Fair, MO sediment deposition after historic rainfall in December, 2015**
